Bondlines – Online blade measurements (October 2012 and January 2013)

Department of Wind Energy E Report 2013

DTU Wind Energy E-0036

The BONDLINEs project (EUDP File Number 64012-0128) is subtitled “Regain the operational life time of installed WTG blades with structural defects”. The Objective is to develop, prepare for market and demonstrate an applicable method for regaining operational life of installed wind turbine blades with structural defects based on patented technologies (Bladena) for limiting deformations in panels. In the project this method will be demonstrated on a turbine in operation. The solution will remove the root cause for bond line defects, which are the dominant defect on blades.

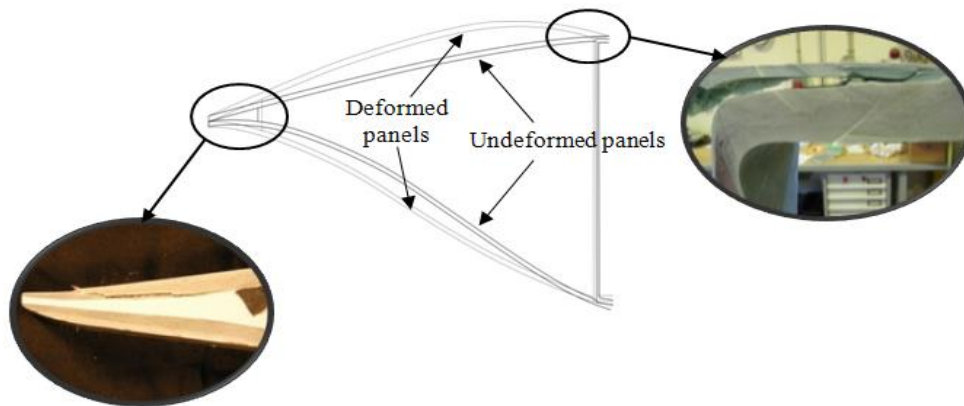
Fig. 1 - Sketch of the trailing edge shells with out-of-plane deformations (the deformations are scaled for clarity). The close-ups show failure at the trailing edge as well as debonding of the outer aerodynamic shell on the box girder.

Looking at the pronounced deformations of the shells, one can have an idea of the “pumping phenomena” which occurs on the blade during operation. Based on this model it is therefore supposed that the cause of debonding is the opening loads near the trailing edge (TE). A strong assumption made on this model is that only MODE I (peeling mode) occurs at the TE debonding, and this can be justified considering that bond-lines have a lower strength when exposed to peeling stresses (MODE I), compared to shear stresses (MODE II). Therefore the interest is to measure only the loads and the displacements normal to the shells surface.

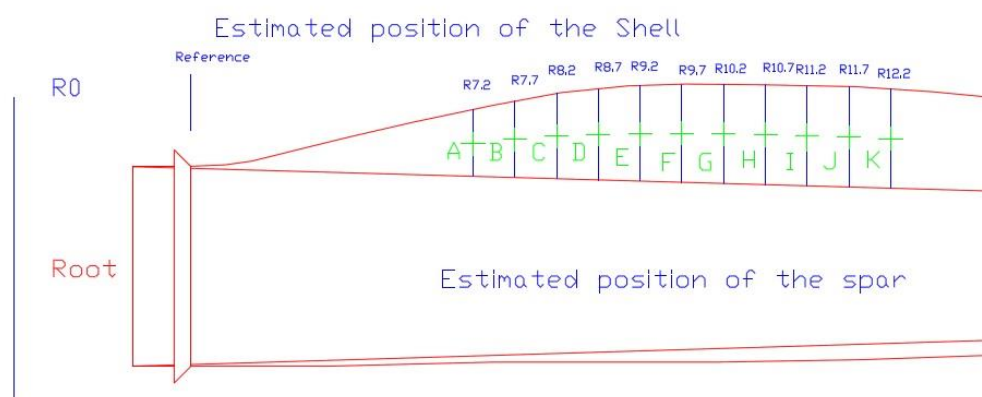
Fig. 2 - Top view of the V80 Vestas WT blade which was tested. 11 sections were defined and the measurement position for each of these can be seen marked with a green cross.

The instruments were intentionally placed on the suction face, which has a flatter profile compared to the higher pressure surface and therefore more suitable to house the devices.

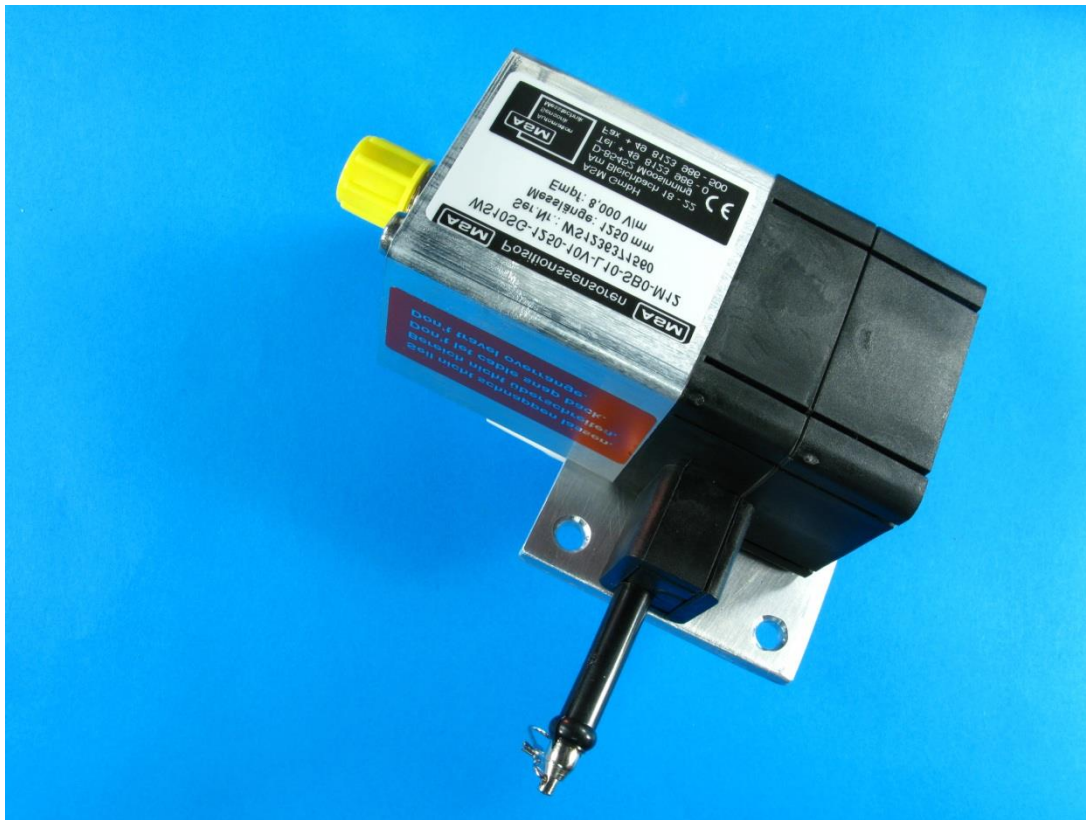
Fig. 3 – POSIWIRE WS10SG string pot from ASM, which was used in the test to measure the relative displacement between the shells in the defined points. In the picture can be noticed the connection plate then screwed to the laminate.

In figure 3 the adopted displacement transducer with the wiring and fixing solution can be seen. Basically the string potentiometer is a transducer which gives a linear response of the displacement using a cable on a spring-loaded spool.

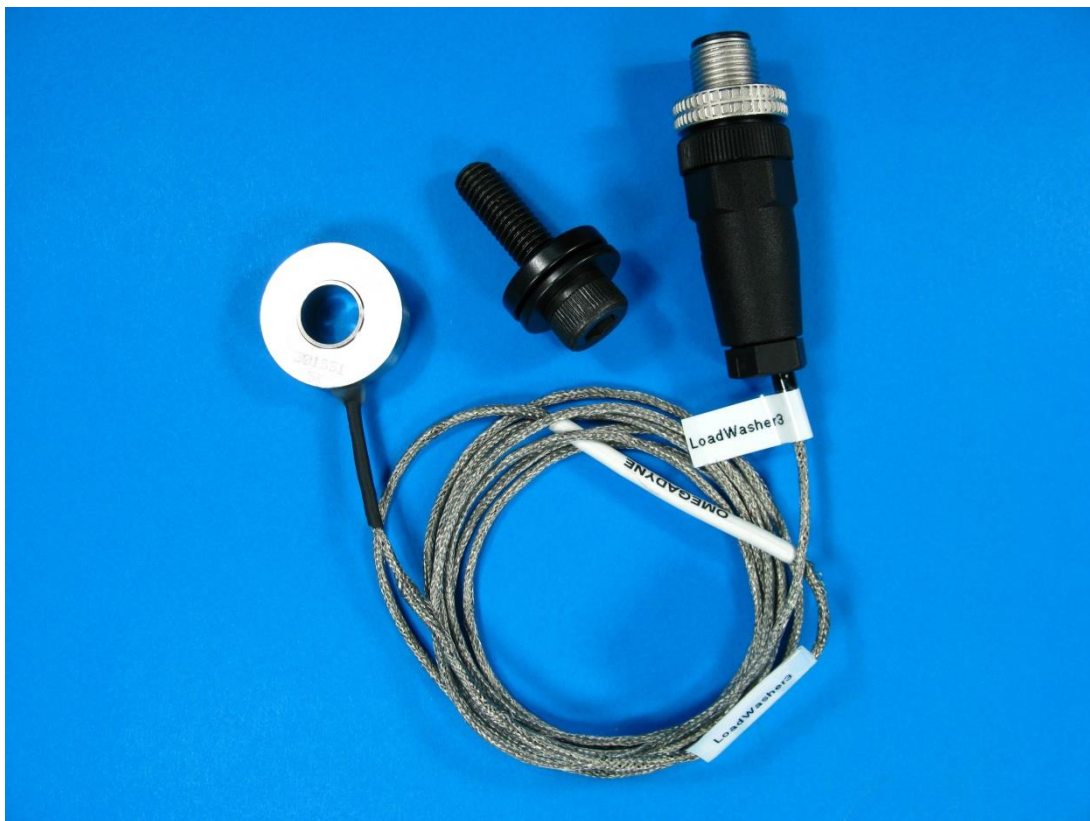
Fig. 4– LOAD WASHER LCMWD-20KN from OMEGA adopted to measure the compressive load on the bolt connecting the two shells of the TE. The load cell is mounted by means of a proper designed plate through the drilled holes in the sandwich panel. The load washer is connected to a 2,5 mm diameter string fixed through a plate to the lower panel. Any adjustment in the alignment is allowed thanks to the spherical washer set – “IGUS washer”, which provide a proper load distribution on the load cell. The initial tension on the string (compression on the load cell) is adjusted by screwing the fitting button on top (not showed in figure), in order to have a stiff configuration.

In figure 4 one can see the load cells adopted to measure the compressive load on the bolted connection at the TE. This specific design of load cell is called load washer, due to the fact that it is mounted as a washer in a rigid bolted connection.

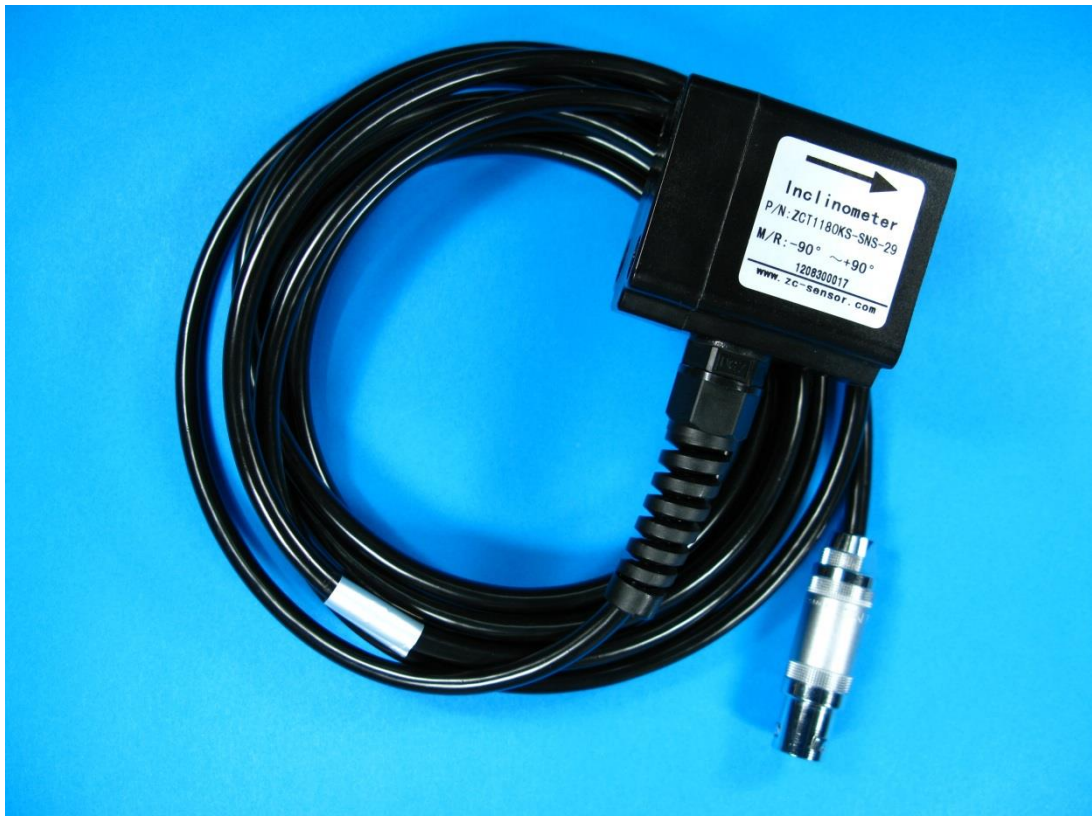
Fig. 6 – 1-axis Inclinometer sensor ZCT1180KS-SNS-29 by ZC Tech. The measuring range goes from -45° (-90°) to 135° (90°) and the analog voltage output vary from 0,5V to 4,5V.

In order to couple the measured load and displacement to the rotational angle of the blade, an inclinometer was used. This could give us a better understanding of the worse load situation depending on the influencing parameters and, moreover, it could help us to interpret the dependency of the loads and displacements at the TE with the rotational speed. In figure 6 the selected inclinometer is showed.

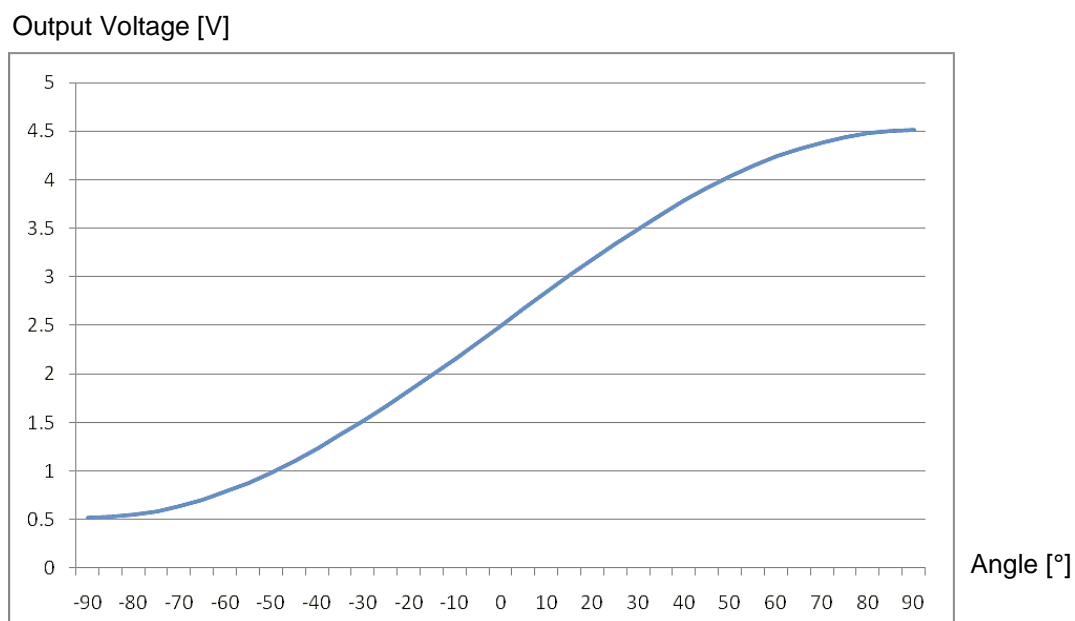
Fig. 7 – Characteristic transfer curve for the inclinometer: the output voltage from the inclinometer is not a linear function of the angle. This means that, as the angular speed is constant (19 rpm) and the acquisition frequency rate too, the acquired points will be differently spaced (time based acquisition rate) in the non-linear region.

The characteristic curve for the inclinometer is shown in figure 7: as can be noticed the transfer function is not linear along the full range of the instrument. This has revealed to be an issue, since the acquisition rate was time based (fixed acquisition frequency), and the resulting acquired points were differently spaced in the region close to -90° and 90°.

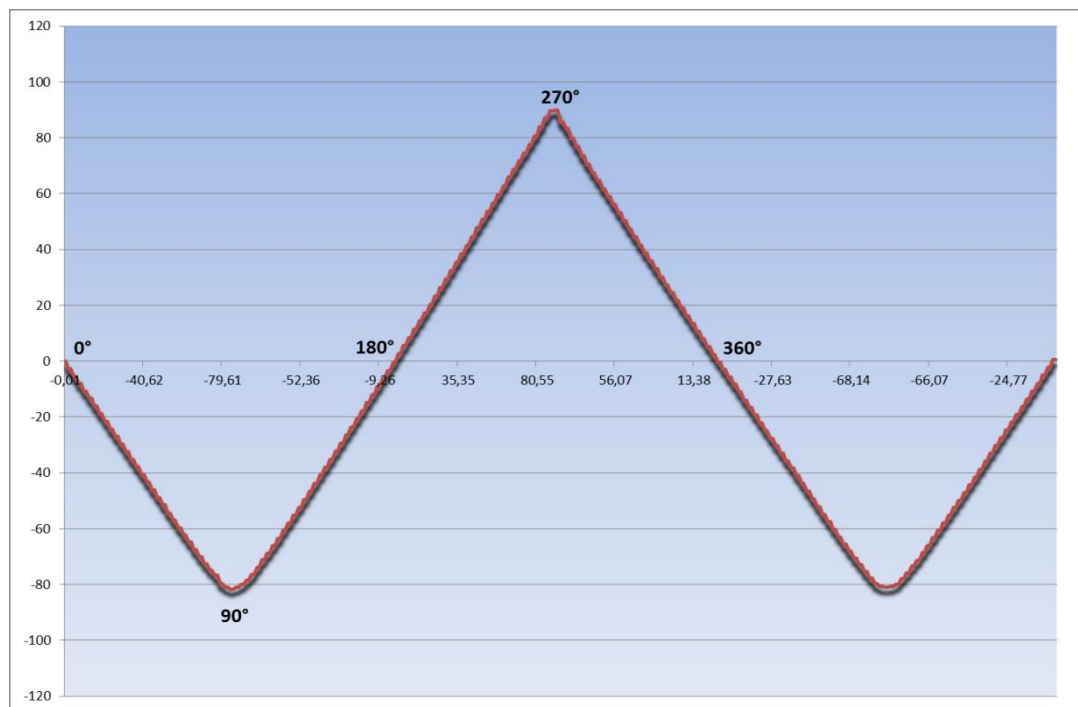
Fig. 8 – Zoom resulting from an acquired set of data through the inclinometer sensor. The raw data were acquired in Volt and further post processed, applying the transfer function of the instrument, to obtain the indicated curve in degrees versus time. It can be noticed that each position (min, max and intersections with the time axis) correspond to an absolute position of the blade.

In figure 8 a screenshot of the acquired data from the inclinometer is proposed with the evidence that the position is always known even in a range of 180° .

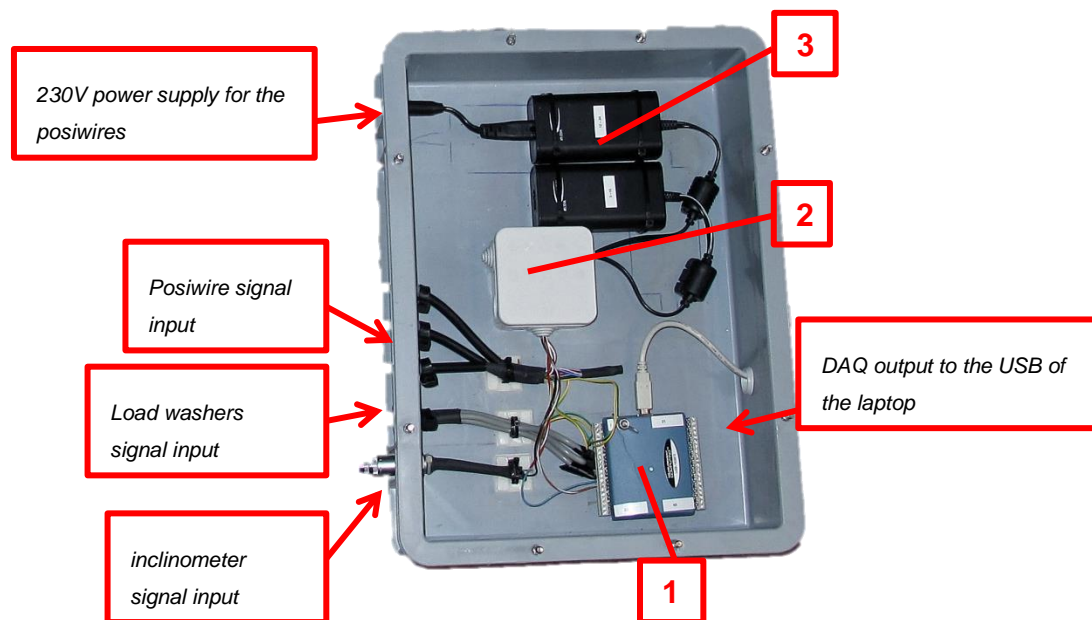
Fig. 11 - Connections case 50x30x10 cm where the DAQ card was allocated (1) with the cabling box (2) and the posiwires power supply (3). On the bottom left side one can see the cables from the posiwires, the load washers and the inclinometer, while on the right side the output to the Laptop running the DasyLab acquisition program. On the upper left the power plug for the posiwire transformer supply.

As already mentioned all the measured signals were sent to the Data Acquisition Card USB-1608FS from Measurement Computing, which was allocated in the grey plastic case, showed in figure 11.

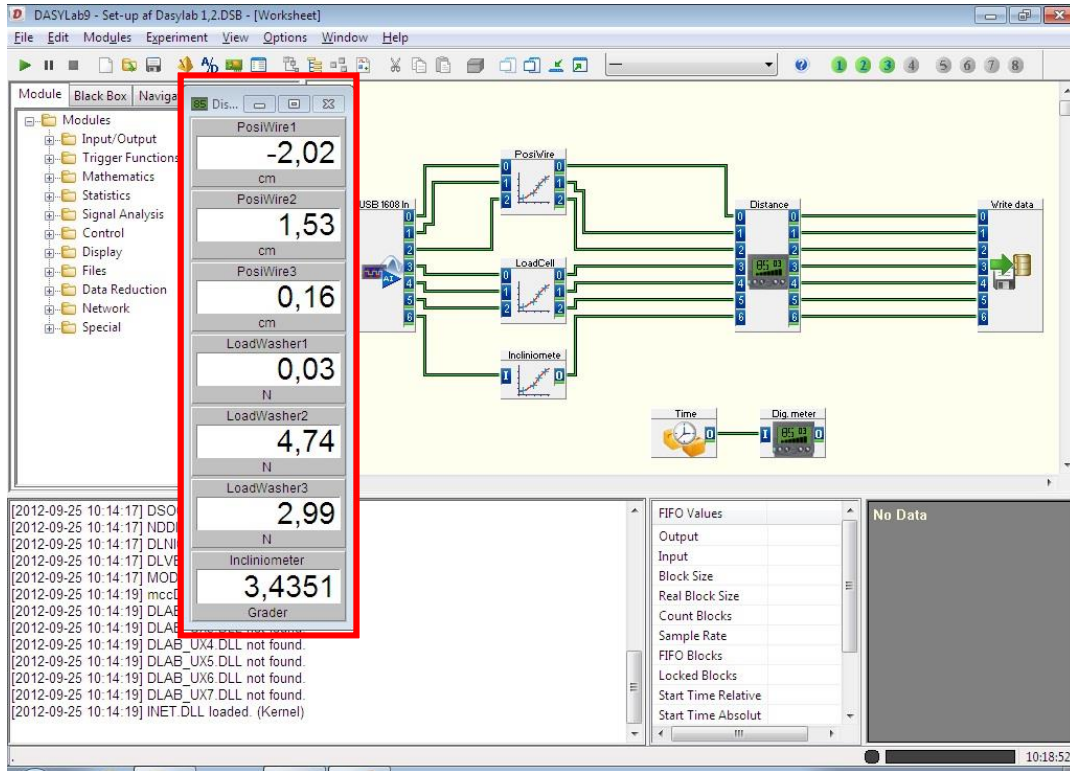
Fig. 12 – Block diagram main window of DasyLab: the highlighted in red window shows all the instant values acquired. As can be easily understood the signal coming from the DAQ – USB 1608 In block – are defined **RESPECTIVELY** – PosiWire, LoadCell and Inclinometer block diagram – and then stored through the write data block. The time block synchronize the laptop internal clock with the starting of the acquisition.

In order to acquire all the data, a block diagram was designed in DasyLab which allow us to store in the local solid disk of the laptop a text file with a header related to the test conditions. For brevity in this subparagraph the DasyLab block diagram main window is shown, while the start-up procedure will be explained in the following sections.

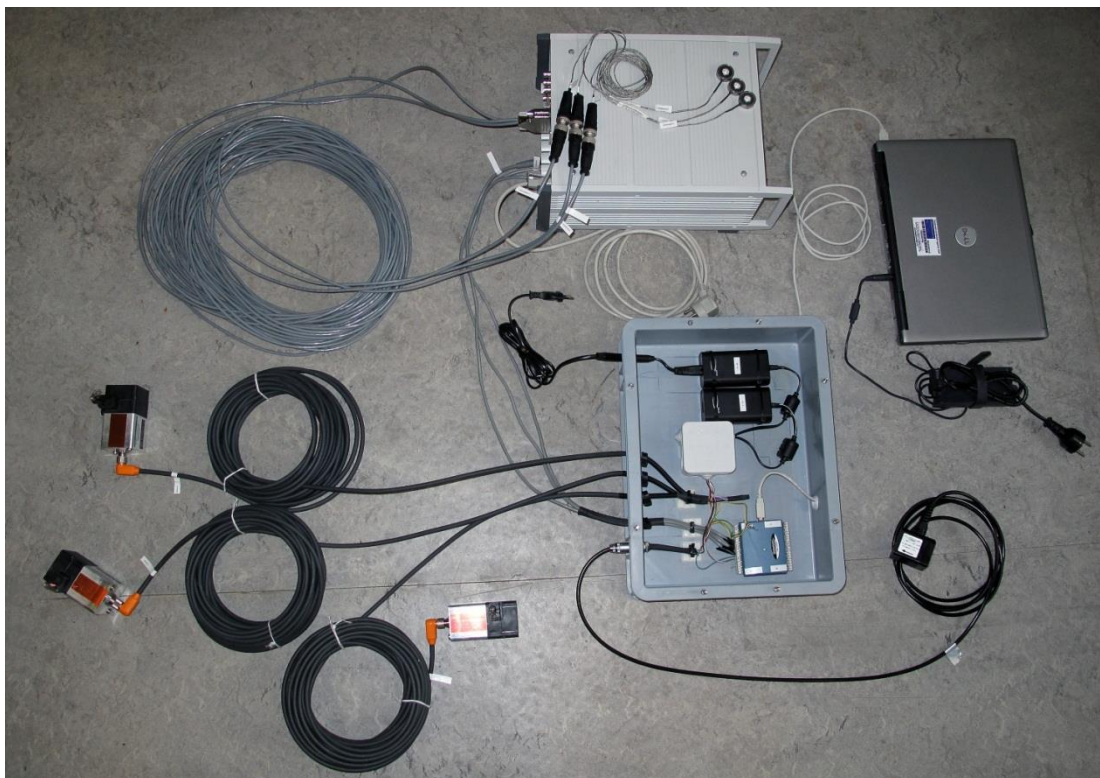
Fig. 13- Complete view of the instrumental set-up used for the field measurements. The laptop running DASyLab (point 1), 3 load washers with the relative amplifier (indicated with 2 and 3), 3 “posiwire” string pots (indicated with 4), the connections box with the data acquisition card (point 5 and 6), the inclinometer (point 7).

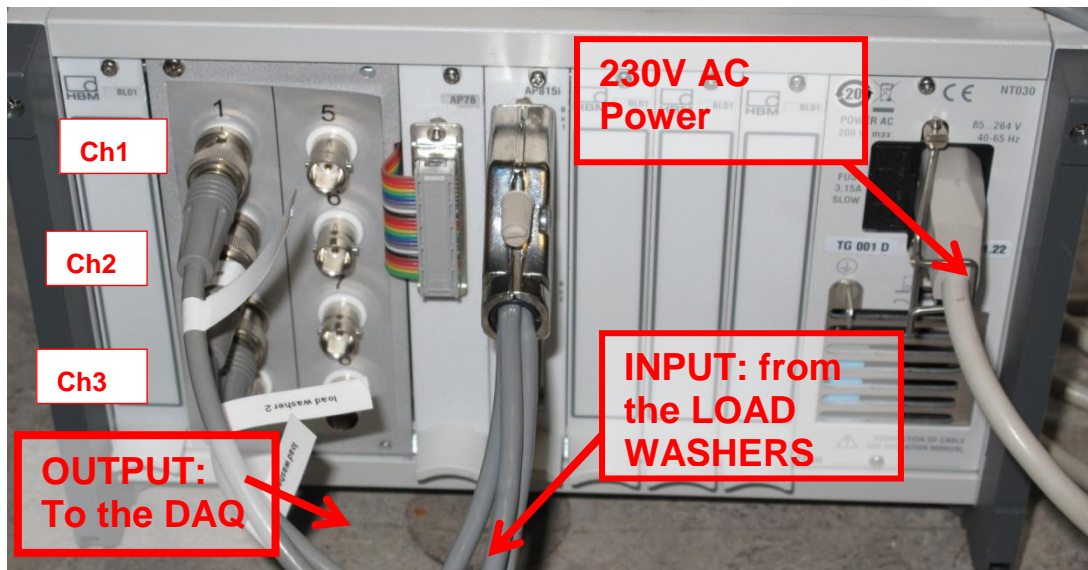
Fig. 14 - Detailed view of the back HBM amplifier connection: as one can see the 3 coaxial cable are the numbered output and are connected to the DAQ through the connections box, while the input coming from all the 3 load washers are connected through a 25-pins connector. On the right the power source of the amplifier can be noticed.

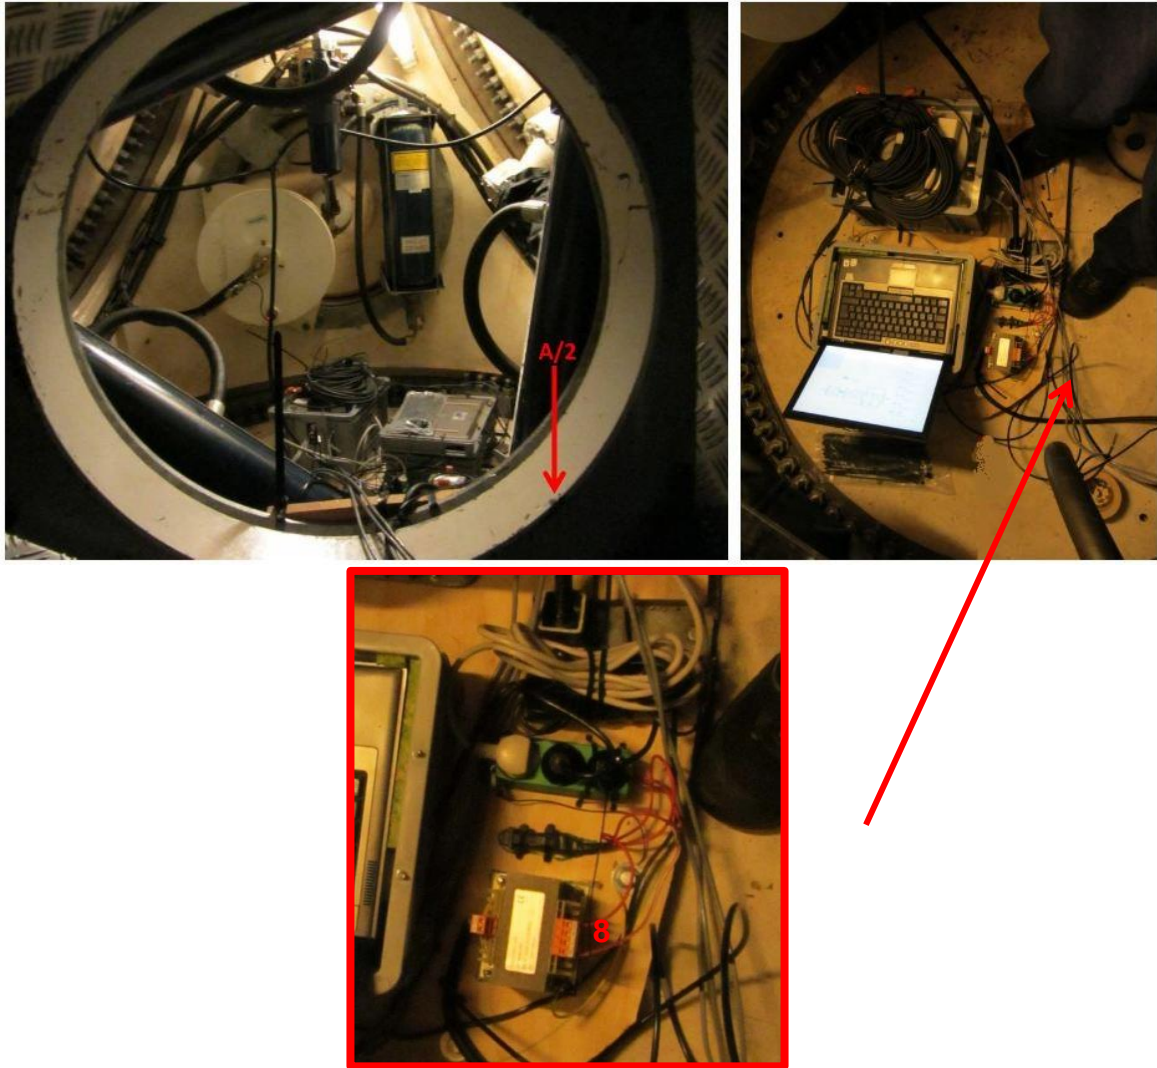
Fig. 15 – Rotor hub hollow space view where the DAQ system was mounted. Both the Laptop and the Amplifier were enclosed in a grey box properly modified with cooling hollows and Plexiglas cover; these were stacked one to each other close to the rotational axis of the WTG. In the bottom figure indicated with a red arrow, zoomed view of the inverter (point 8 on the list) which was needed to convert the power supply took from the auxiliary to a proper 230V AC required from the instruments.

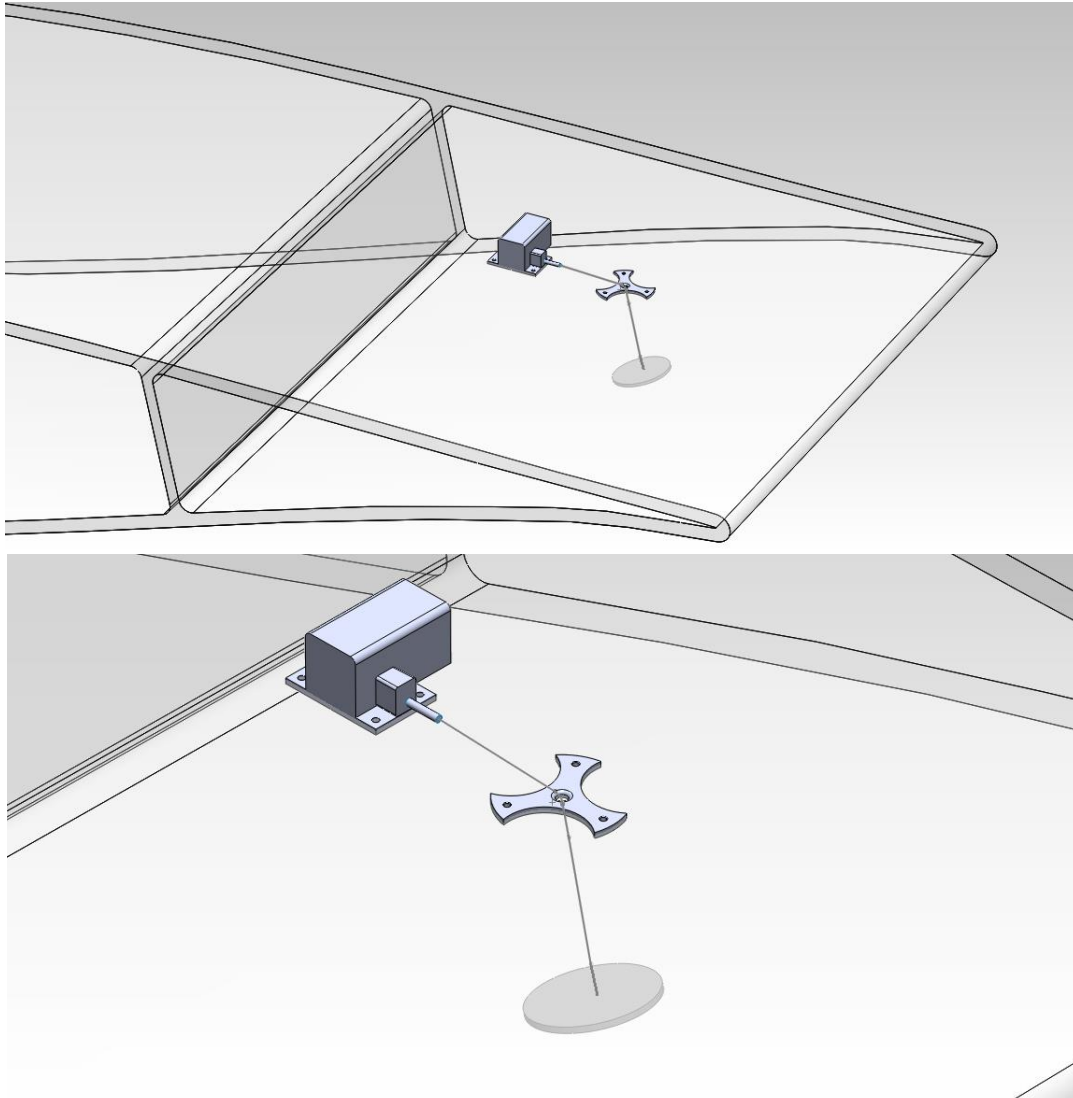
Fig. 16 – Schematic 3D model of the adopted fixing solution for the posiwires on the suction profile of the WTB V80 from Vestas. The posiwire is screwed through an aluminium plate directly to the sandwich panel, the (triskelion) shaped plate on the upper surface allows the string to be aligned with the axis of the posiwire and ensure a smooth curvature of the string. A hole on the shell allows the string to connect upper and lower shells and measure the relative displacements, the lower end of the string is attached to the lower panel by means of an aluminium plate screwed directly on it.

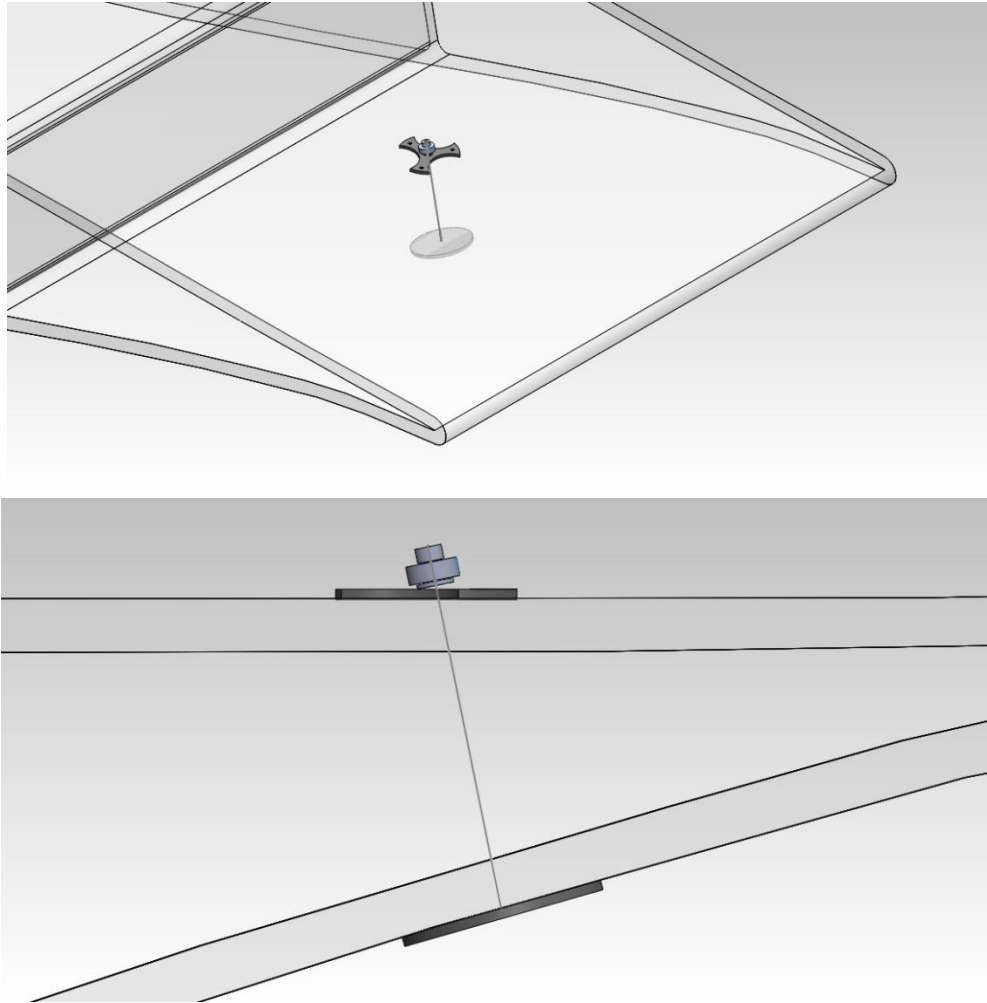
Fig. 17 - Schematic 3D model of the adopted fixing solution for the load washer on the suction profile of the WTB V80 from Vestas. A hole on the shell allows the bolt to be connected through a string to the lower shell.

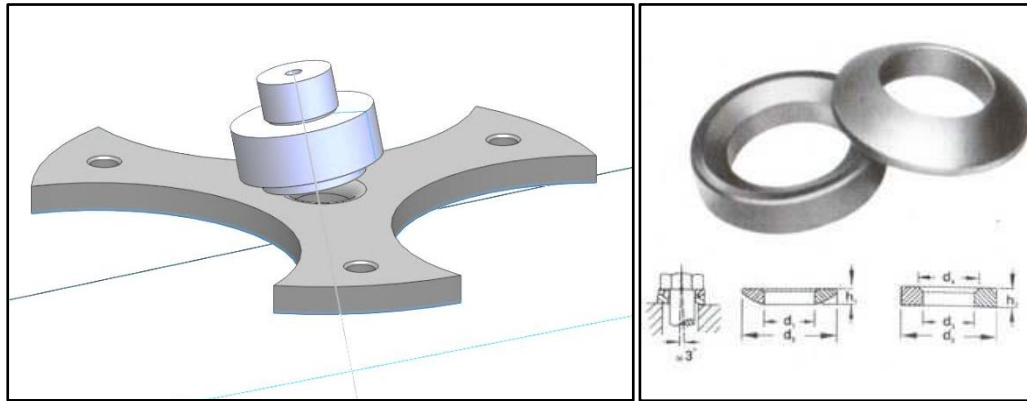
Fig. 18 – Detailed view of the load washer mounting solution adopted: on the left it can be noticed that it was necessary to tilt of an adequate angle the load washer/string connection to have a pure compression stress. We achieved to this adopting proper spherical washers – IGUS washers – showed here on the right.

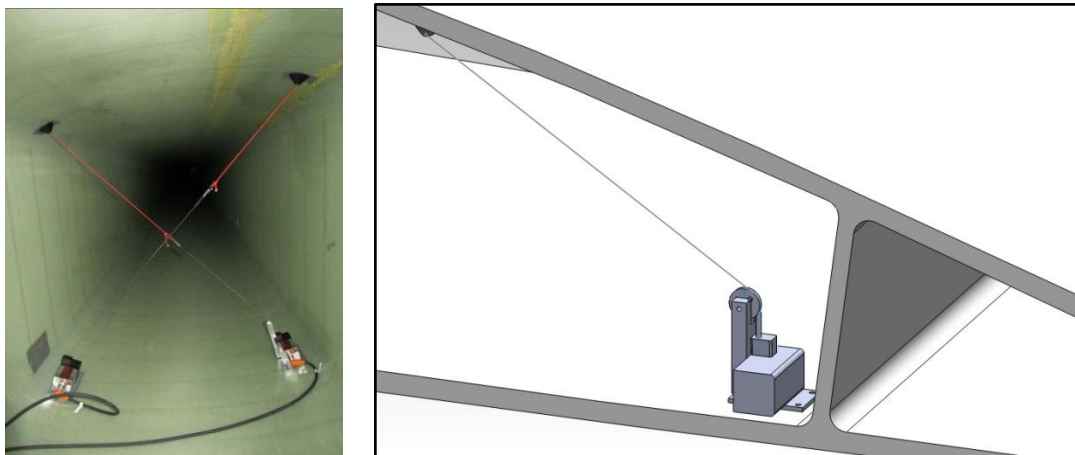
Fig. 19– Realized (left) and 3D schematic (right) fixing solution for the internal “shear displacements” measured with the posiwires at a 10 meters length inside the spar cap. A string was attached with some double side flash tape to the GFRP surface, by means of a plastic cone. The posiwire was mounted in a vertical position on the opposite surface, using this double side flash tape. A pulley was manufactured in order to direct the string in a correct way, avoiding any friction.

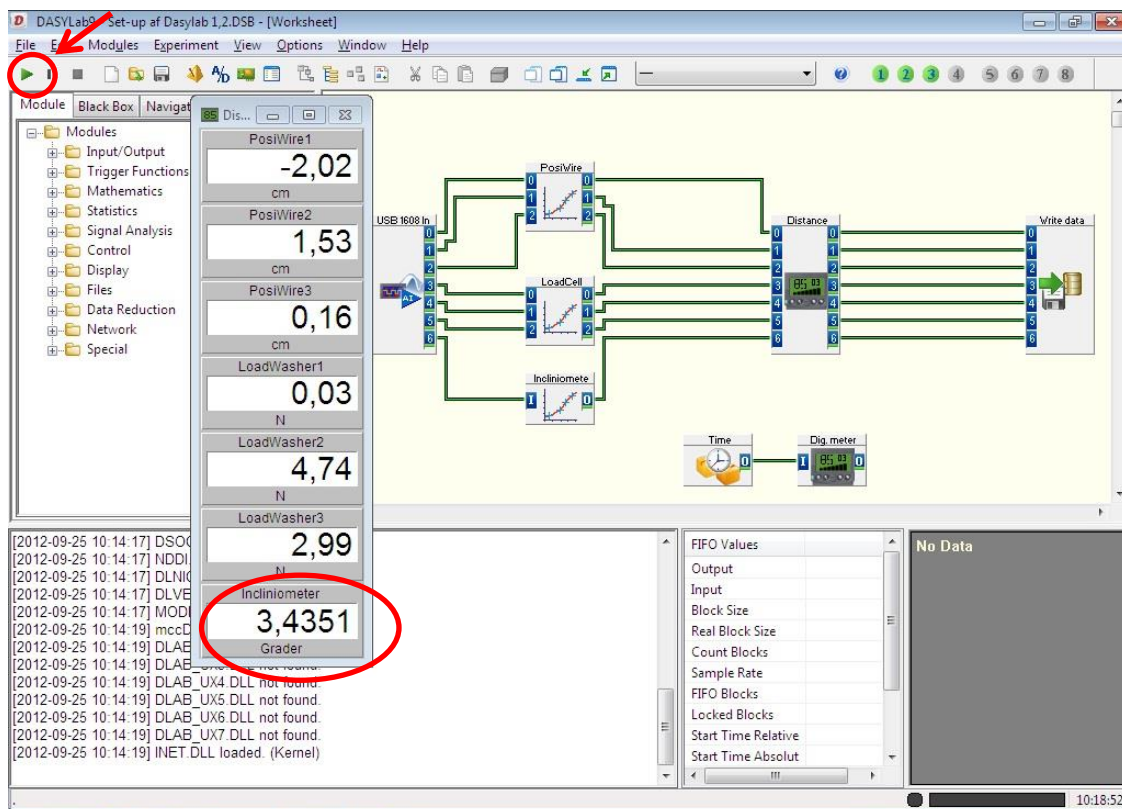
Fig. 22 - Main screenshot of the DASYLab setup file. The vertical window displays the instant acquired values from the connected instruments. The angle for the inclinometer is identified by the red colour circle and in the calibrating procedure it has to be as close as possible to 0° degree reference.

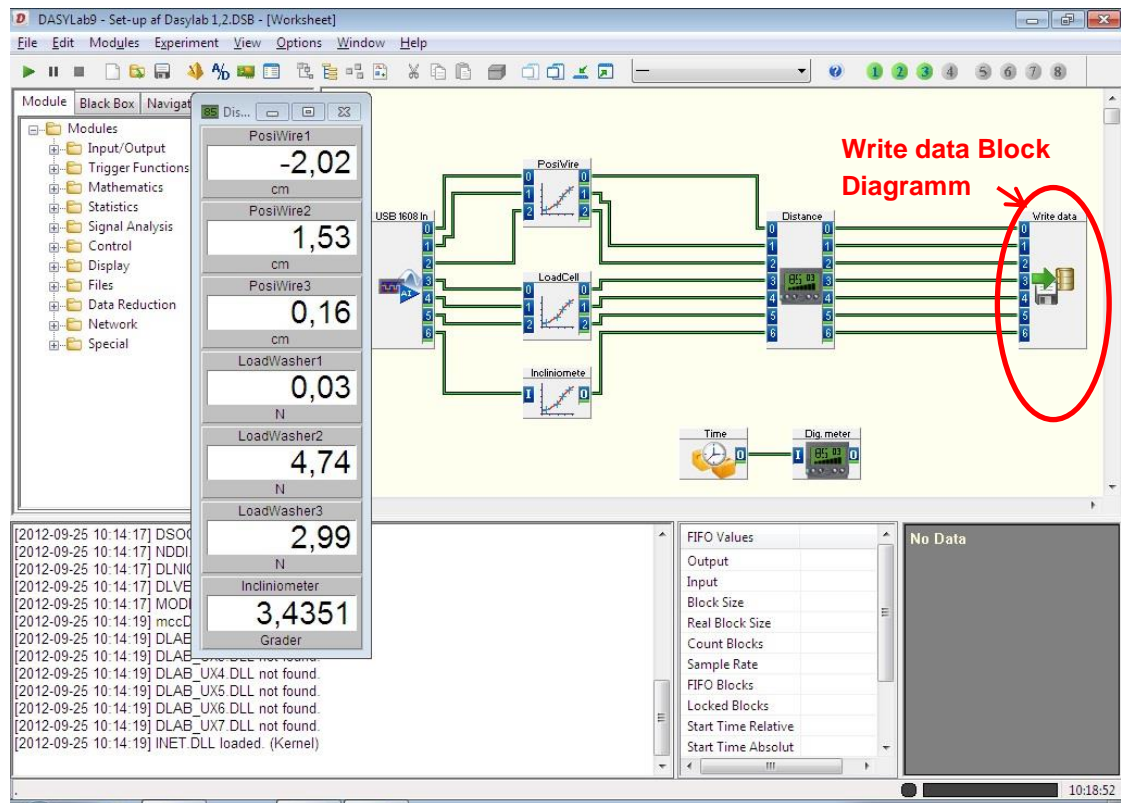
Fig. 23 - Main screenshot of the block diagram: the write data module is highlighted in red colour on the upper right.

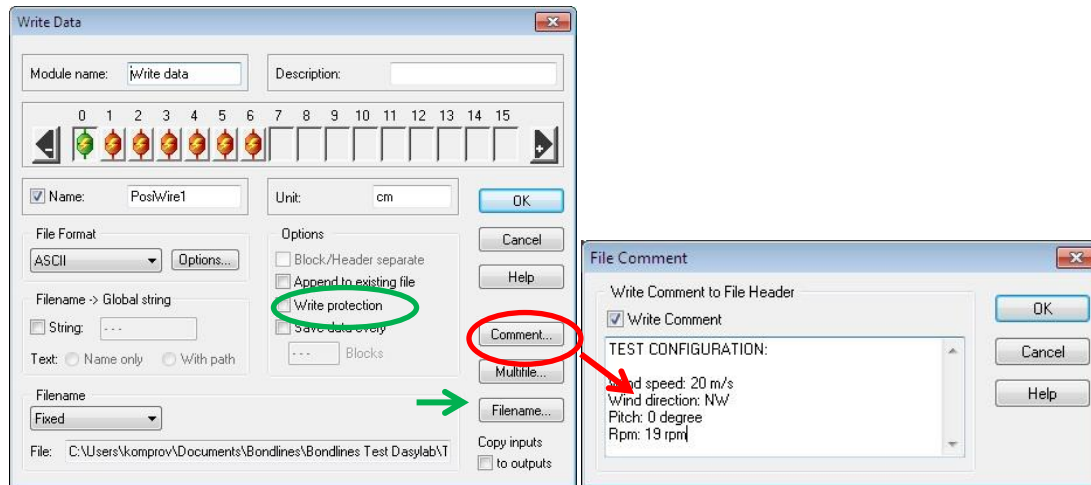
Fig. 24 – Window screenshot of the Write data module at the left and File Comment window on the right. In addition also the Write protection selection has to be flag (circled in green colour) and the Filename (indicated with a green arrow) has to be defined each time a new acquisition is started.

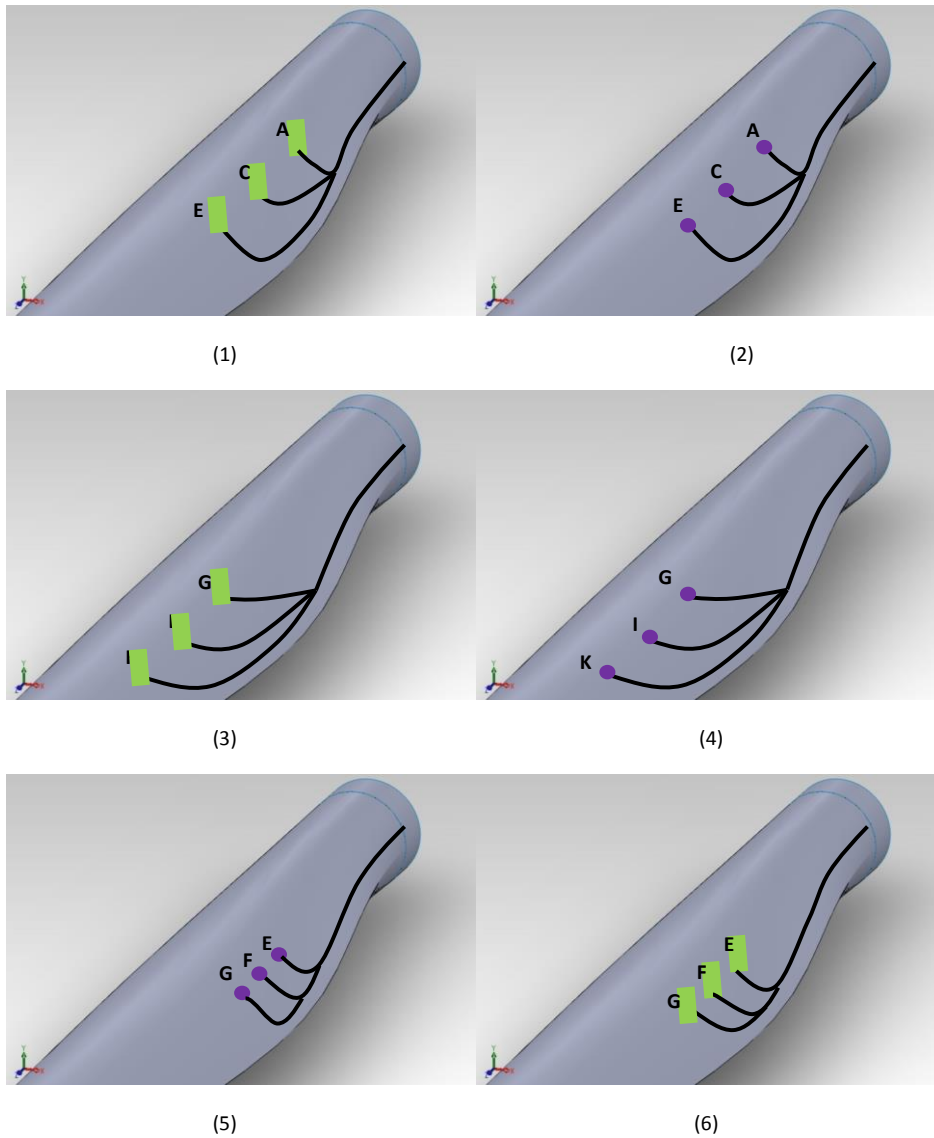
Fig. 25 - Main view of the instrumented blade with highlighted the cables arrangement along the TE. In green colour the 3 string pots, while in purple colour the 3 load washers. (1) 1st set of displacement measurements on section A, C, E in order to find the point where the maximum displacement occur. (2) 1st set of load measurements to acquire the corresponding loads at the same sections A, C, E. (3) 2nd set of displacement measurements on section K, I, J in order to find the point where the maximum displacement occur. (4) 2nd set of load measurements to acquire the corresponding loads at the same sections K, I, J. (5) 3rd set of measurement to acquire the corresponding loads around the maximum displacement point – i.e. F – at different pitch angles. (6) 3rd set of measurement to acquire the corresponding displacements on the same sections – i.e. F – at different pitch angles.

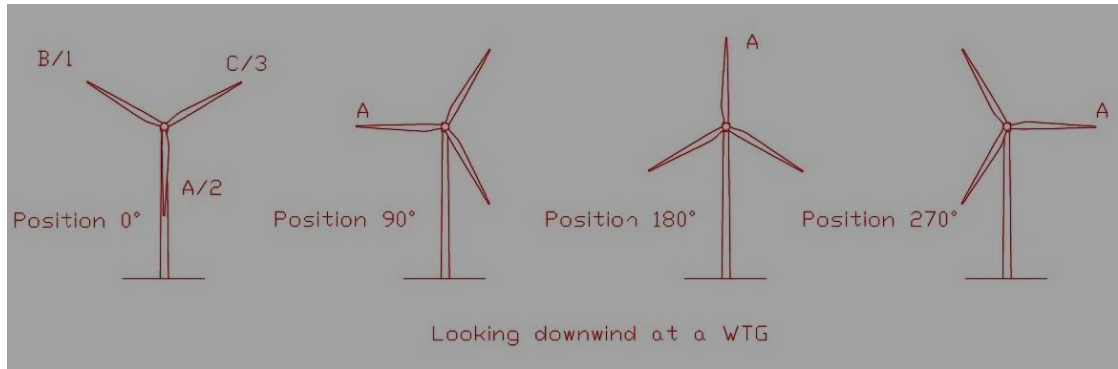
Fig.26 – Schematic representation of different blade positions of interest for the tests. Blade signed A/2, set a 0° reference position, is the chosen one to be instrumented.

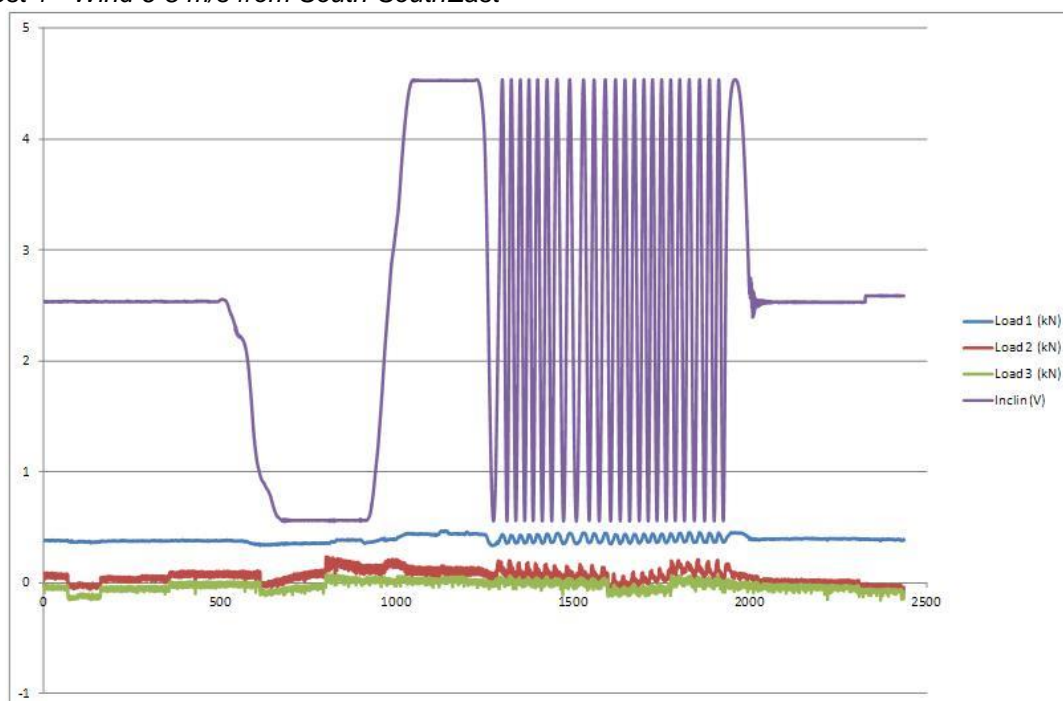
Fig. 27 - Full trace for test 1 (23/oct)

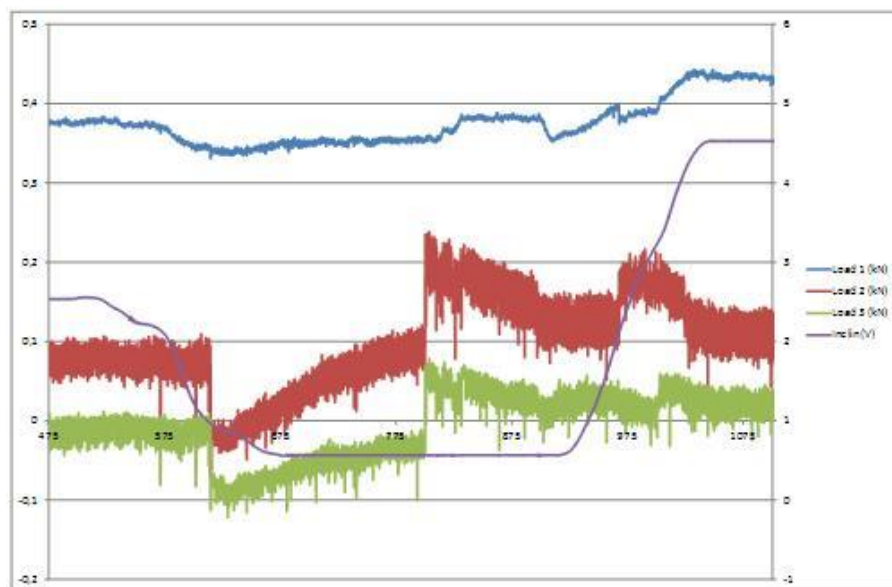
Fig. 28 - Detail from Test 1 showing the blade rotating to the 90° position where the pitch is cycled from 90 deg to 0 deg and then back again

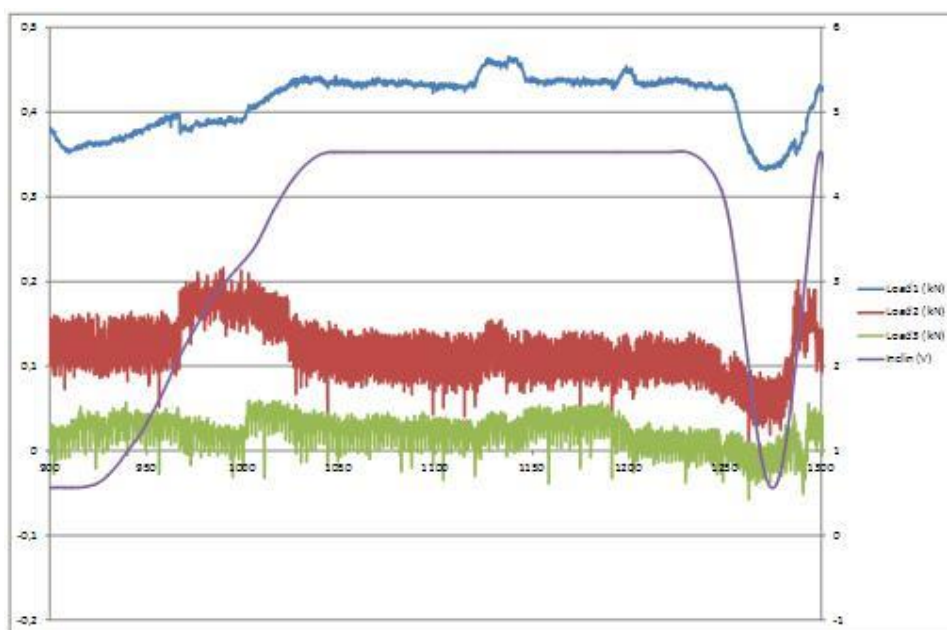
Fig. 29 - Detail from Test 1 showing the blade rotating to the 270° position where the pitch is cycled from 90 deg to 0 deg and then back again

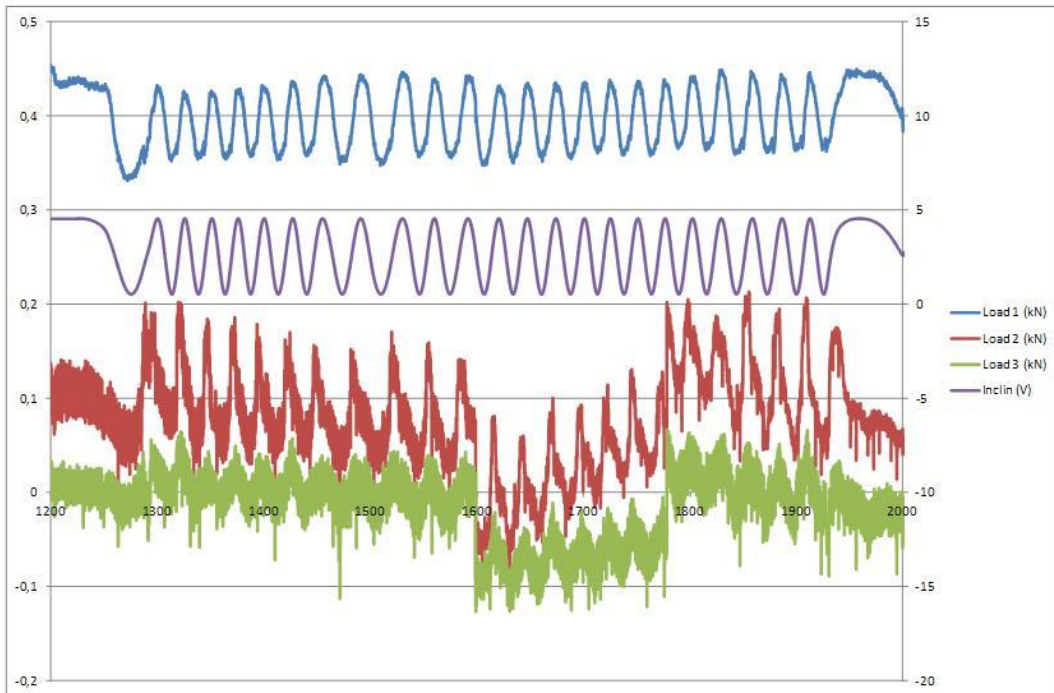
Fig. 30 - Detail from test 1 showing the autorun startup and operation (at close to 0 deg pitch)

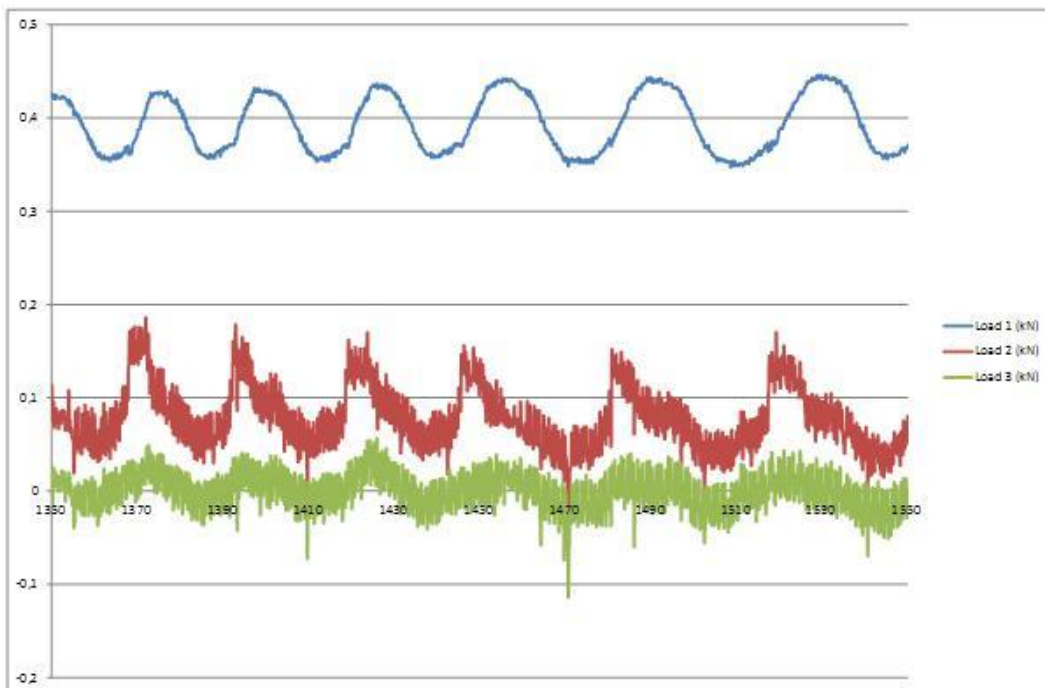
Fig. 31 - Detail of the output from Test 1 showing the most stable part of the autorun condition
